<b>Site Visit Report</b>	MDSHA MS4 (General Permit No. 99-DP-3313) <b>Owings Mills Maintenance Facility &amp; Security Satellite Facility</b> MDSHA District No. 4	Site Visit Date: 11/19/2013
--------------------------	---	--------------------------------

**Facility Name:** Owings Mills Maintenance Facility

**Date of Visit:** November 19, 2013

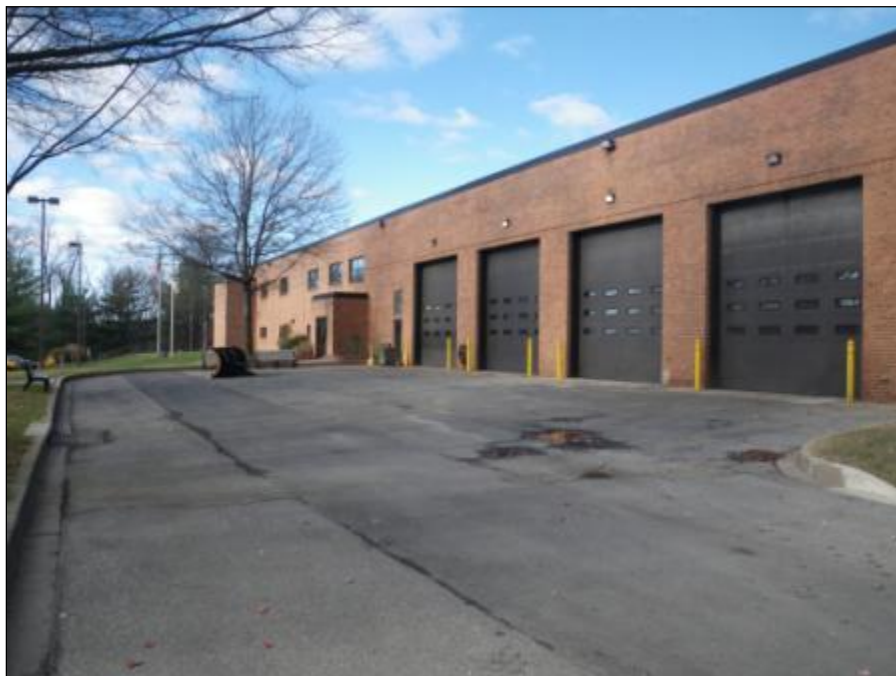
**Photograph 1.** Overview photograph of Owings Mills Maintenance Facility. View of vehicle maintenance shop bays.

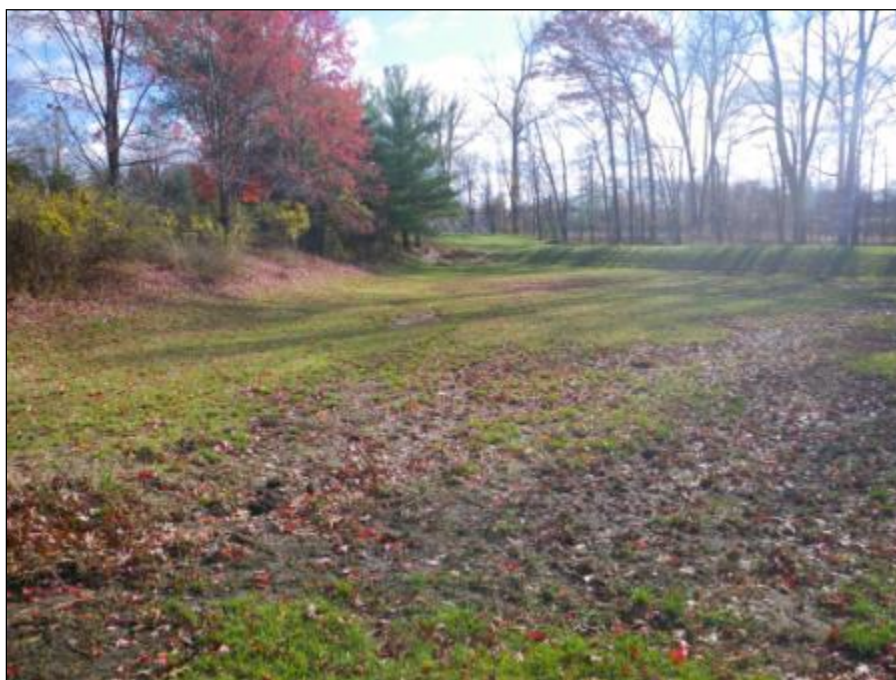
**Photograph 2.** View of permanent stormwater management basin in the southwestern portion of the Facility. Stormwater leaving the basin is discharged offsite.

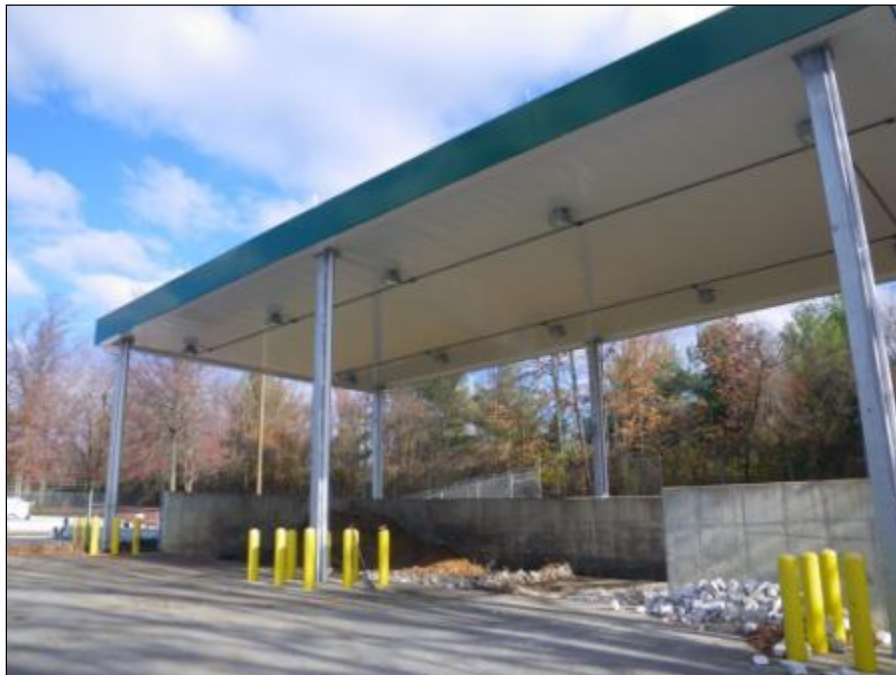
5. The Facility has a structure for dewatering vacuum truck waste material in the northeastern portion of the Facility (refer to Photographs 3 and 4). MDSHA staff explained that the dewatering structure is connected to an oil/water separator and discharges to the sanitary sewer (refer to Photograph 5). The dewatering structure and oil/water separator are inspected quarterly and cleaned as needed by MES. The Shop Chief stated the oil/water separator has been in use at the Facility for about three or four years.

**Photograph 3.** View of the vacuum truck waste material dewatering structure located in the northeastern portion of the Facility.

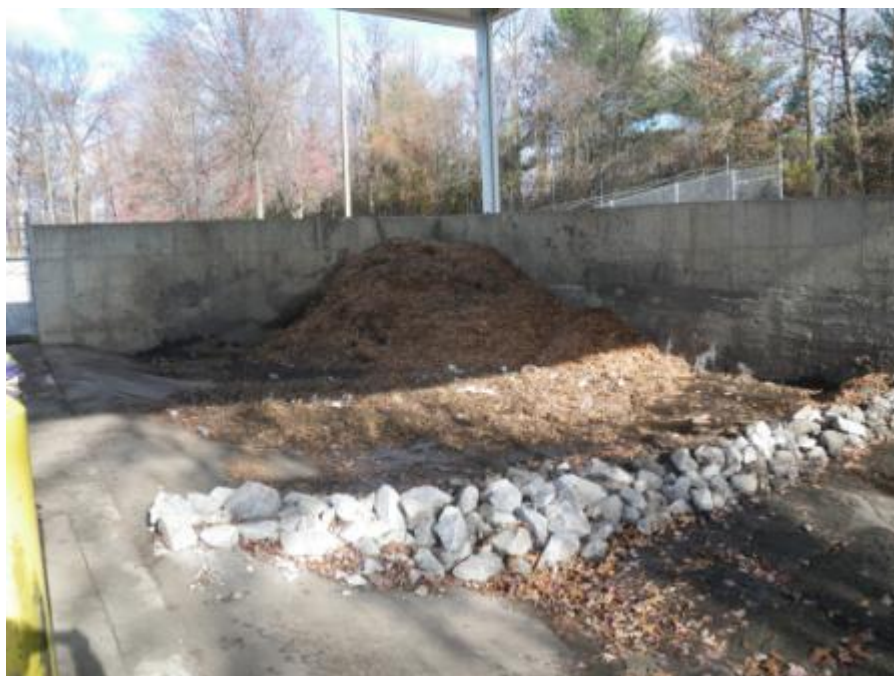
**Photograph 4.** Close-up view of vacuum truck waste material in the dewatering structure.

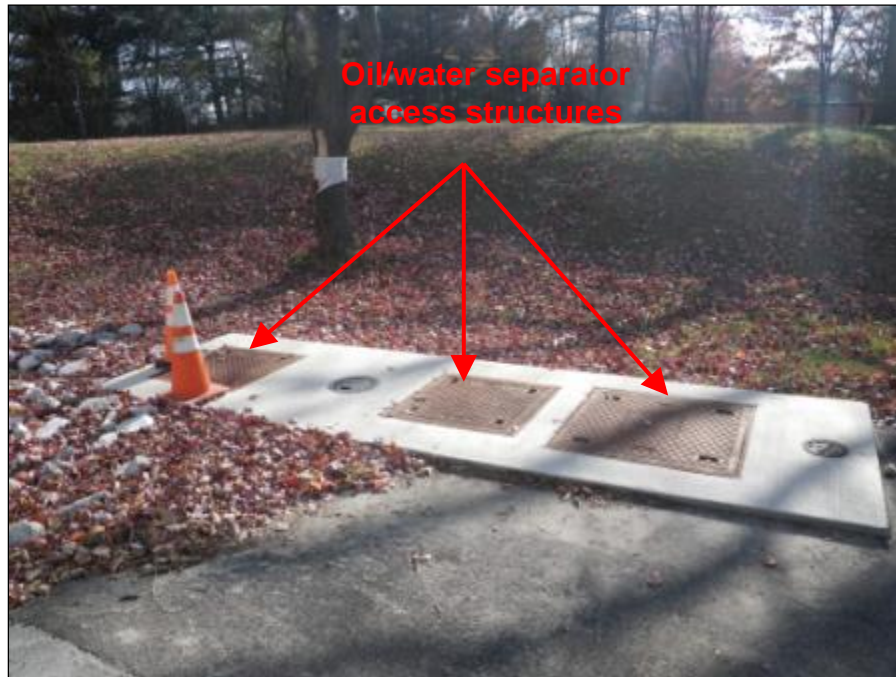
**Photograph 5.** View of the oil/water separator which treats the dewatering structure effluent and discharges to the sanitary sewer.

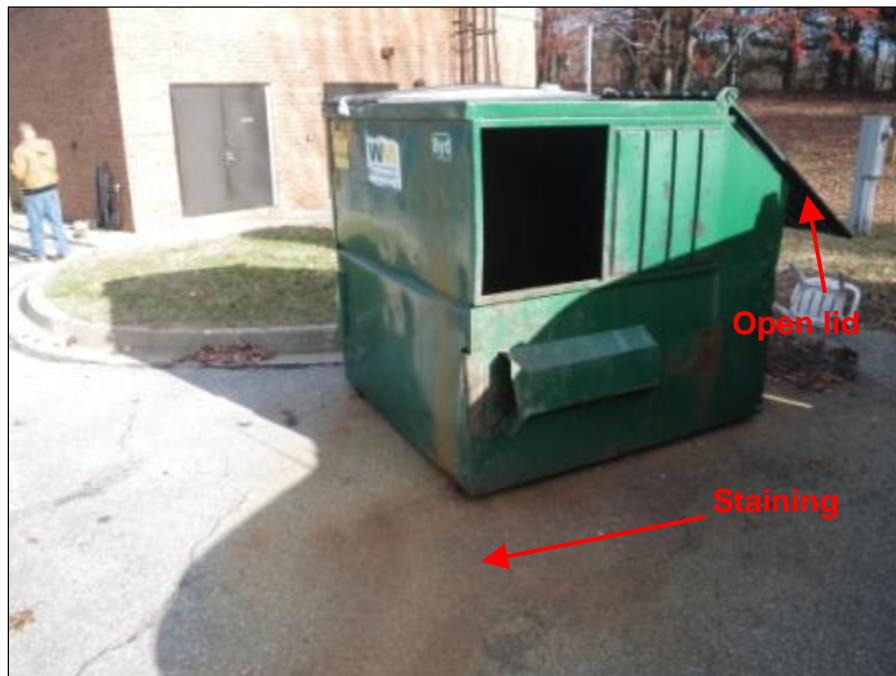
6. A solid waste dumpster located near the southeast corner of a building along the eastern edge of the Facility (Area No. 25 on the Facility site map) was not fully covered at the time of the site visit and staining was present on the adjacent impervious ground surface (refer to Photographs 6 and 7). The Facility site map depicts that stormwater runoff from this area would flow to a storm drain inlet located approximately 175 feet to the west of the dumpster. Table 6 of the Facility SWPPP/SPCC

identifies that the dumpster should be covered and contact with stormwater could lead to leaching of contents.

**Photograph 6.** View of the waste dumpster located near the southeast corner of a building along the eastern edge of the Facility. Note that the dumpster was not fully covered at the time of the site visit and that staining was present on the adjacent impervious ground surface.

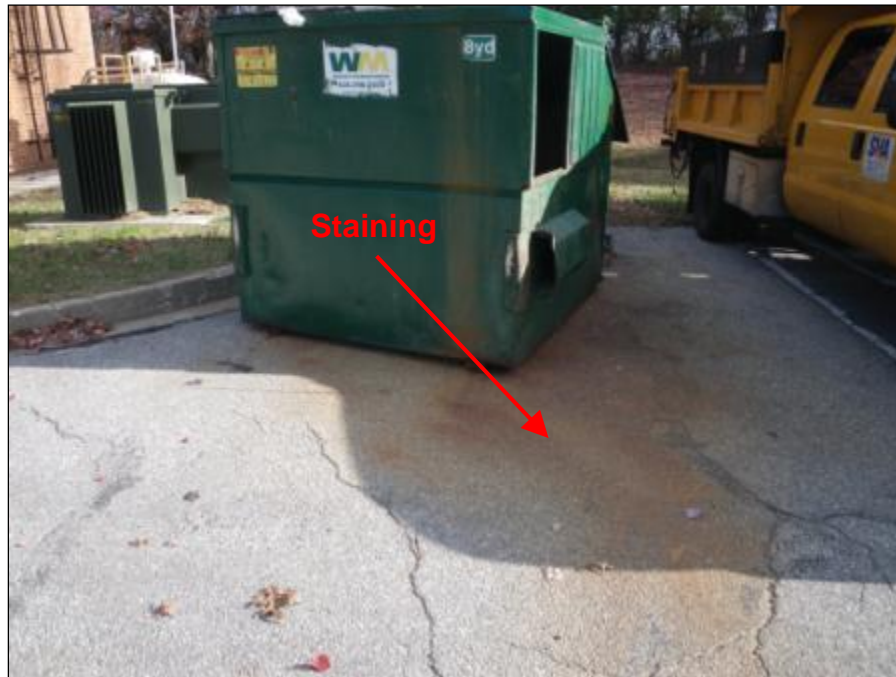
**Photograph 7.** Alternate view of staining on the impervious ground surface adjacent to the waste dumpster.

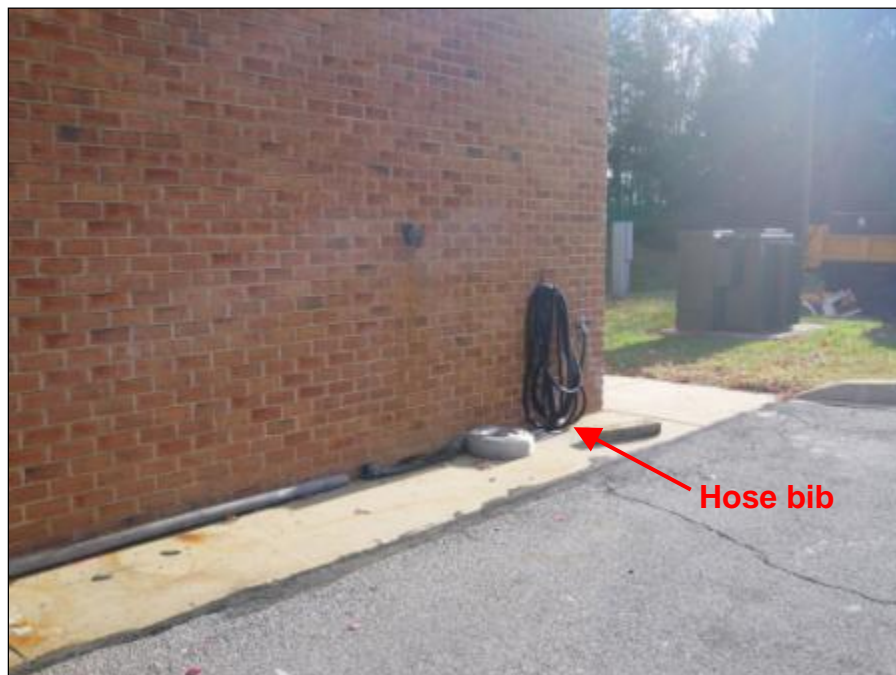
7. A hose bib was present outside of the “Team Leaders Building / Vehicle Storage Building” (Area No. 16 on the Facility site map) without labeling indicating its purpose or restrictions on use (e.g., no vehicle washing; refer to Photograph 8). Facility staff explained the hose bib is typically used for filling large water tanks on the back of trucks. In addition, two 55-gallon drums used as solid waste disposal receptacles were present along the building but were not labeled to identify them as such (refer to Photographs 9 and 10).

**Photograph 8.** View of a hose bib located outside of the “Team Leaders Building / Vehicle Storage Building.” Note that the hose was not labeled in order to indicate its purpose or usage restrictions.

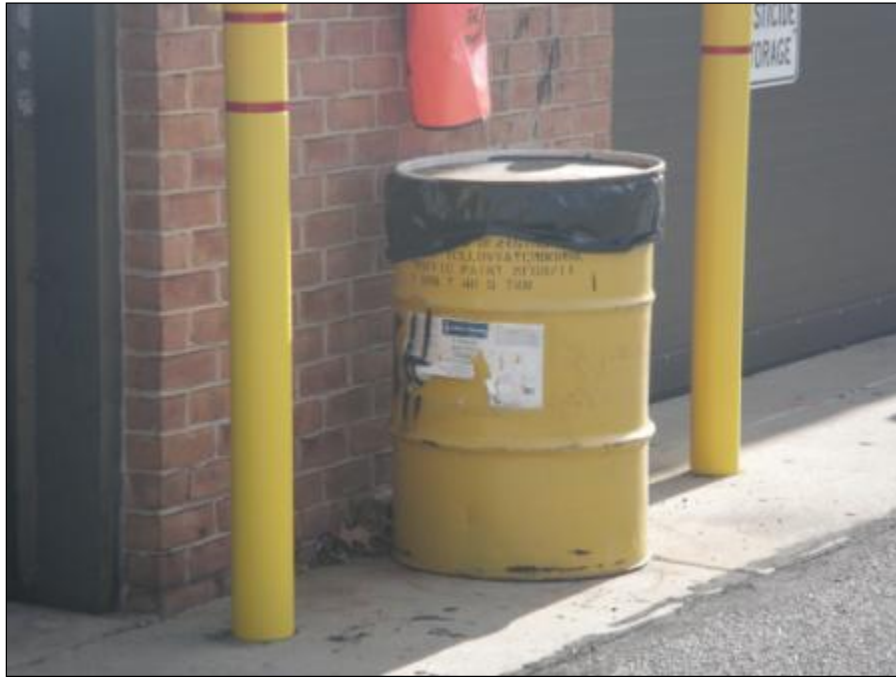
**Photograph 9.** View of one of two 55-gallon drums used for solid waste disposal, located along the outside of the “Team Leaders Building / Vehicle Storage Building.” Note that the drum was not labeled to identify the contents.

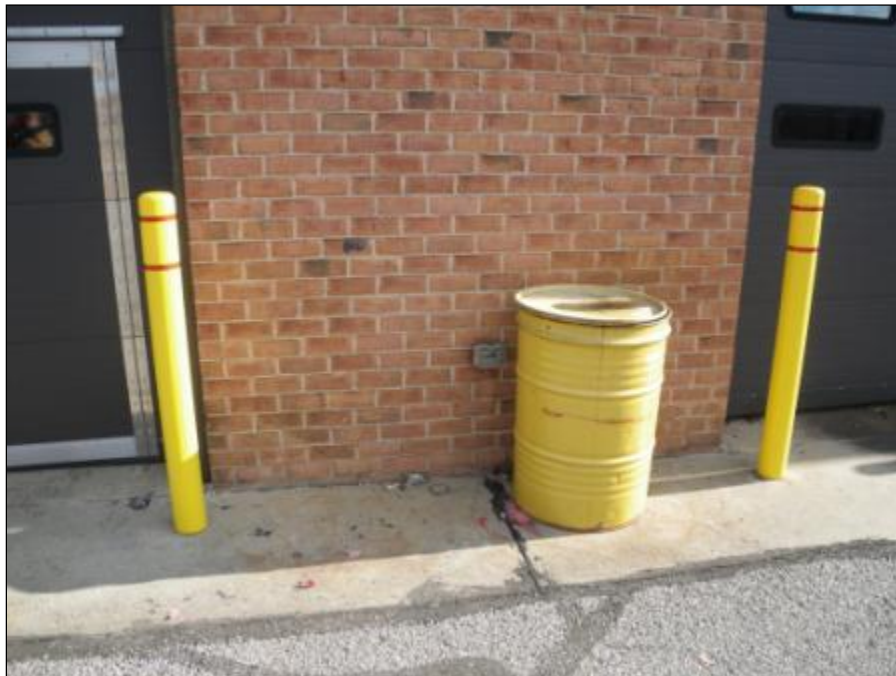
**Photograph 10.** View of the additional 55-gallon drums used for solid waste disposal, located along the outside of the “Team Leaders Building / Vehicle Storage Building.” Note that the drum was not labeled to identify the contents.

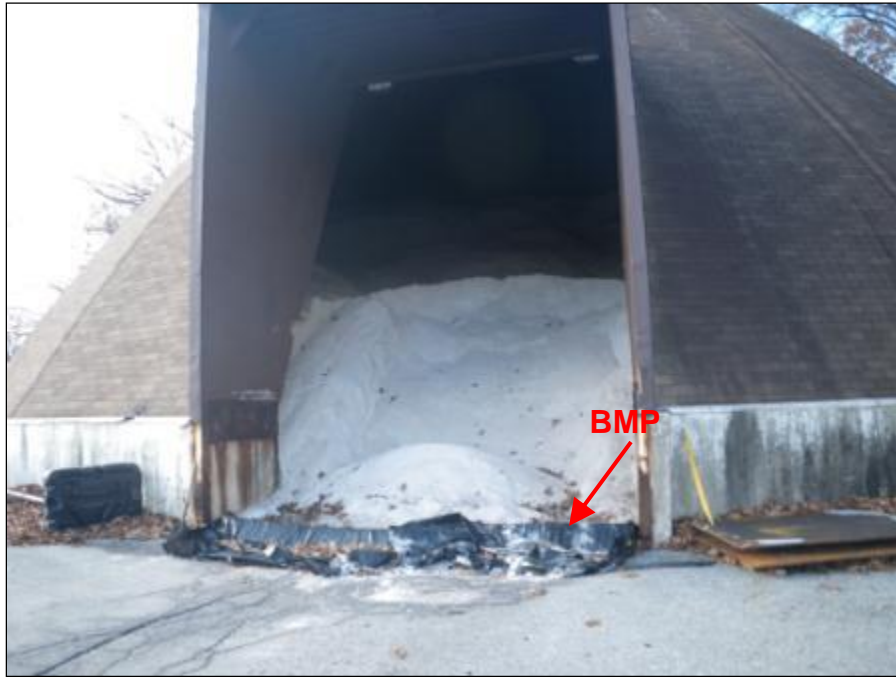
8. Salt and white salt residue was present on and beyond the perimeter control best management practice (BMP) located at the entrance to the salt storage dome in the northwestern portion of the Facility (refer to Photographs 11 through 13). The DEC explained that the BMP was a piece of foam material covered with filter fabric. This BMP is described in Table 6 of the Facility SWPPP/SPCC. The Facility site map depicts that stormwater runoff from this area would flow to a storm drain inlet located approximately 200 feet to the east of the salt storage dome.

**Photograph 11.** View of the salt storage dome in the northwestern portion of the Facility. Note that salt was observed beyond the perimeter control BMP located at the entrance.

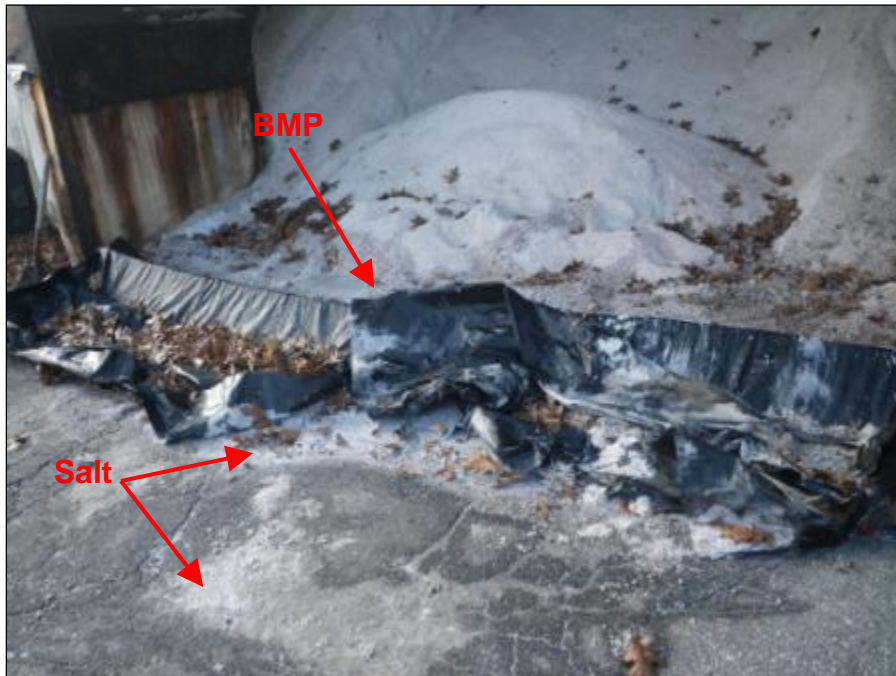
**Photograph 12.** Close-up view of salt and white salt residue beyond the perimeter control BMP located at the salt storage dome entrance.

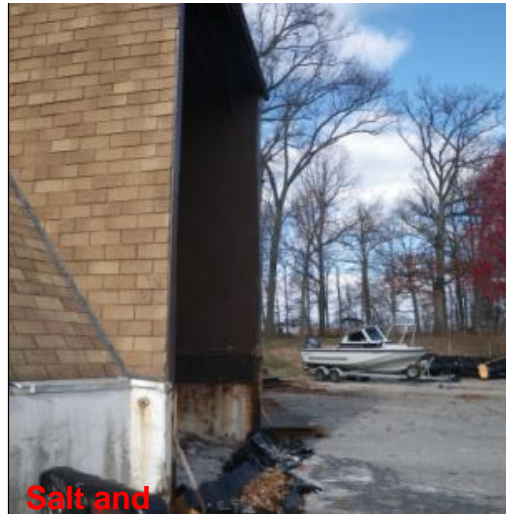
**Photograph 13.** Alternate view of salt and white salt residue beyond the perimeter control BMP located at the salt storage dome entrance.

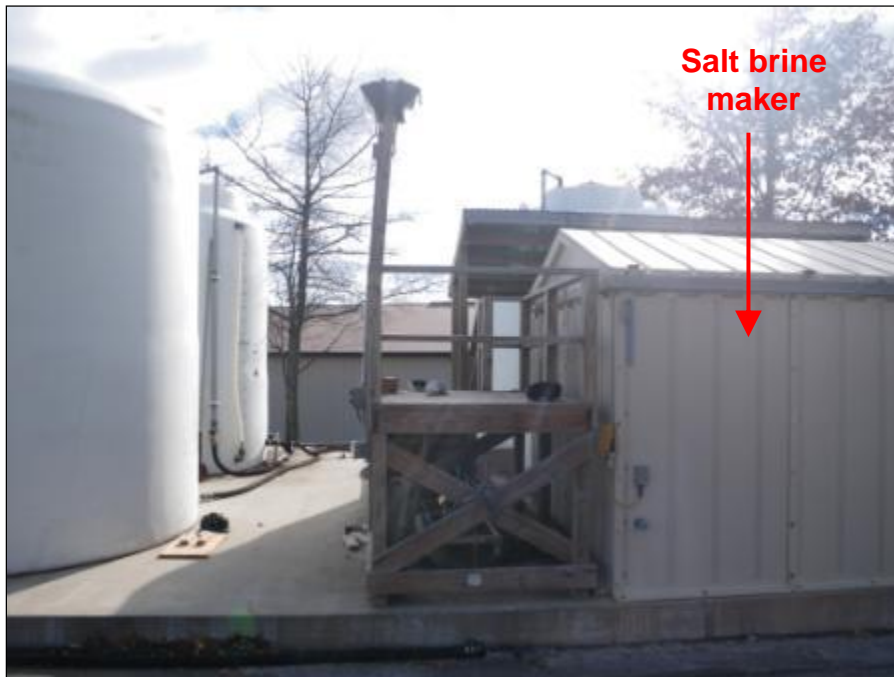
9. The magnesium chloride storage tank and salt brine storage tanks located in the north-central portion of the Facility (Area No. 13 on the Facility site map) were not located within secondary containment (refer to Photographs 14 and 15). The Facility site map identifies that a storm drain inlet is located approximately 100 feet to the east of the storage tanks.

**Photograph 14.** View of the magnesium chloride and salt brine storage area and tanks located in the north-central portion of the Facility. Note lack of secondary containment.

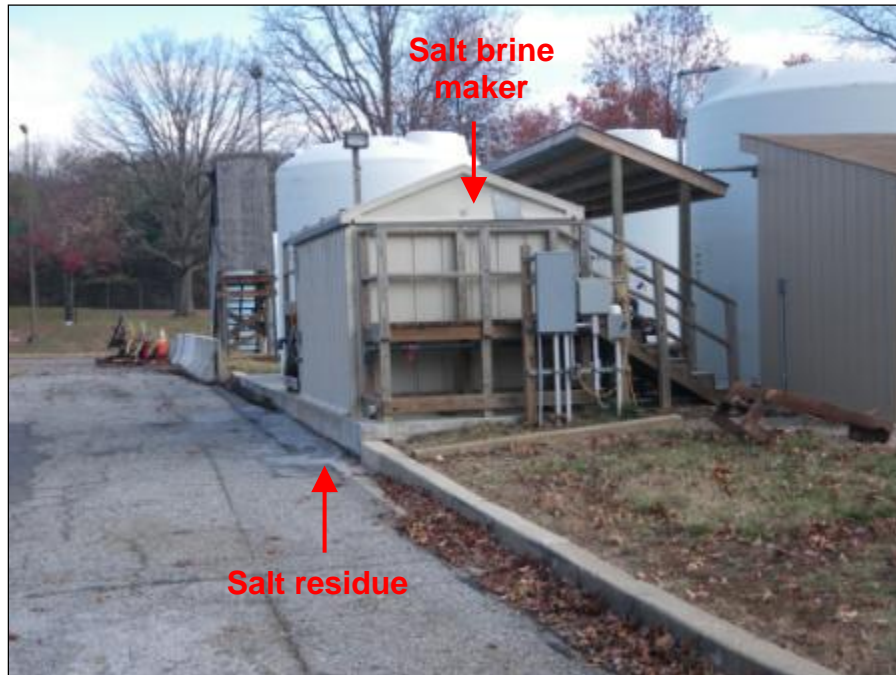
**Photograph 15.** Alternate view of the magnesium chloride and salt brine storage area and tanks located in the north-central portion of the Facility. Note lack of secondary containment. Also note white salt residue in the curblane adjacent to the salt brine maker.

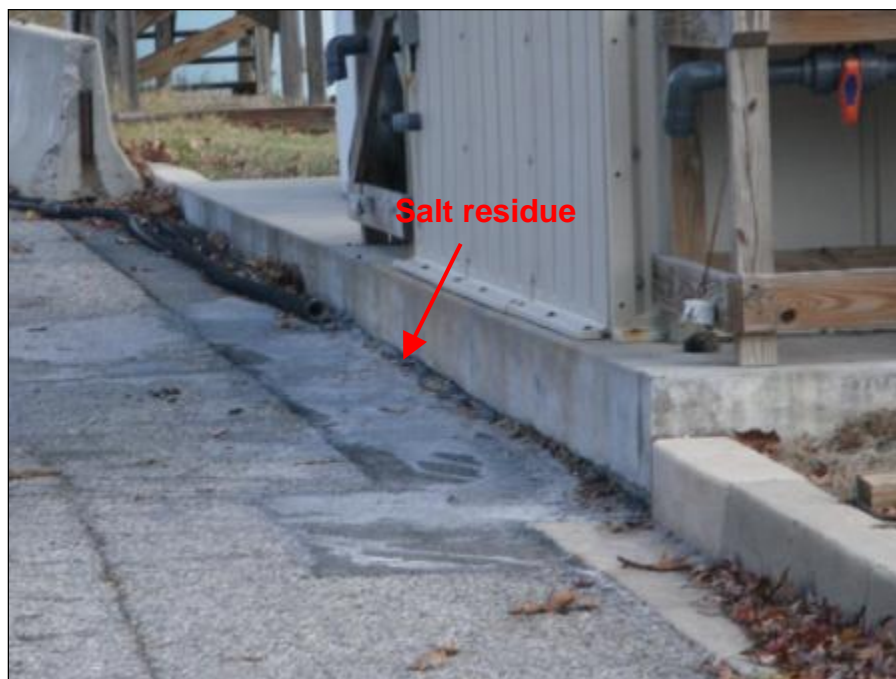
10. Salt residue was present on the impervious ground surface adjacent to the salt brine maker in the north-central portion of the Facility (Area No. 13 on the Facility site map; refer to Photographs 15, 16, and 17).

**Photograph 16.** Close-up view of white salt residue in the curblane adjacent to the salt brine maker shown in previous photograph.

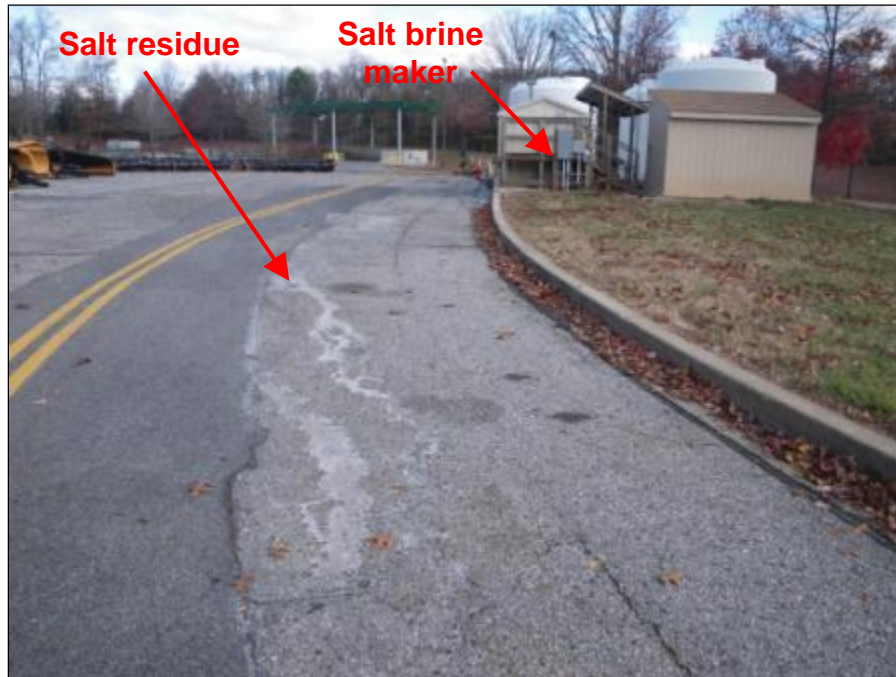
**Photograph 17.** View of white salt residue on impervious ground surface downgradient of the salt brine maker.

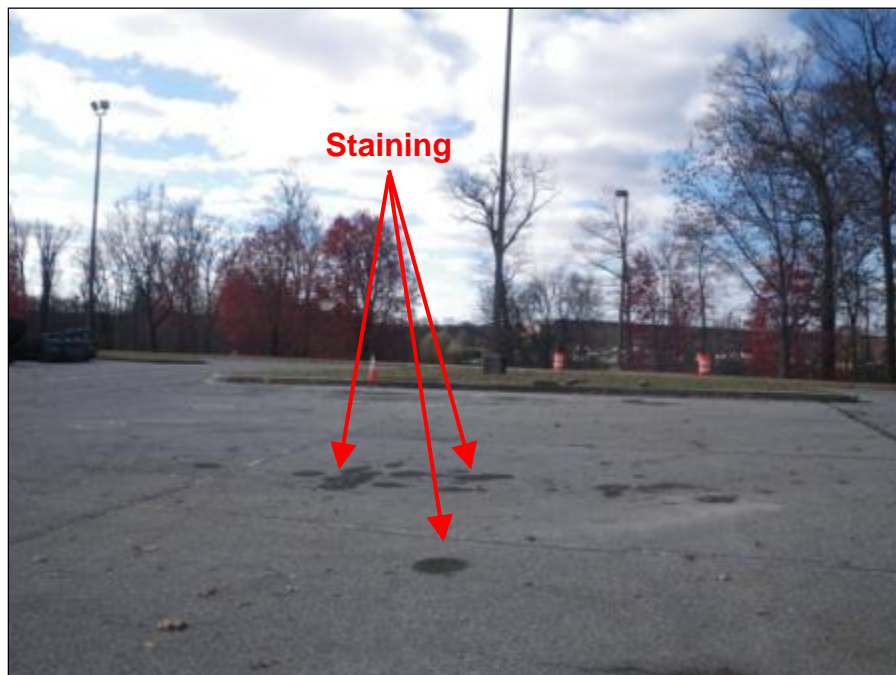
11. Staining was present on the impervious ground surface in a vehicle parking area directly to the southwest of an equipment storage building at the Facility (Area No. 17 on the Facility site map; refer to Photograph 18). In addition, an absorbent rag with petroleum product was present in this area (refer to Photograph 19). The Shop Chief explained that this is the type of issue he would note during his weekly inspection of the Facility and address with his staff. The Facility site map depicts that stormwater runoff from this area would flow toward a storm drain inlet approximately 150 to the east of the parking area.

**Photograph 18.** View of staining on the impervious ground surface in a vehicle parking area directly to the southwest of an equipment storage building at the Facility.

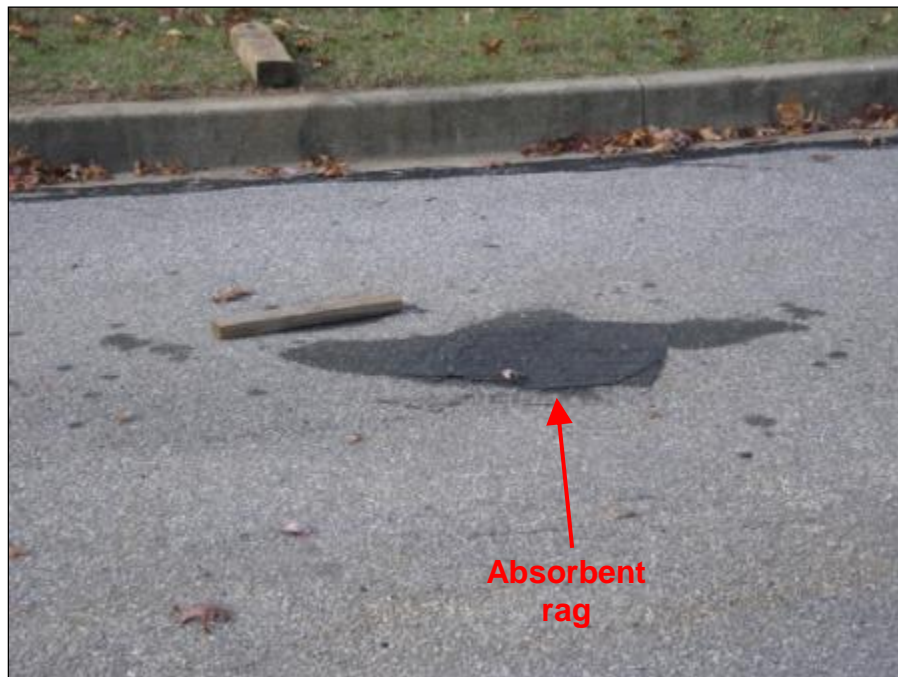
**Photograph 19.** Close-up view of staining and a petroleum-soaked absorbent rag in area shown in previous photograph.

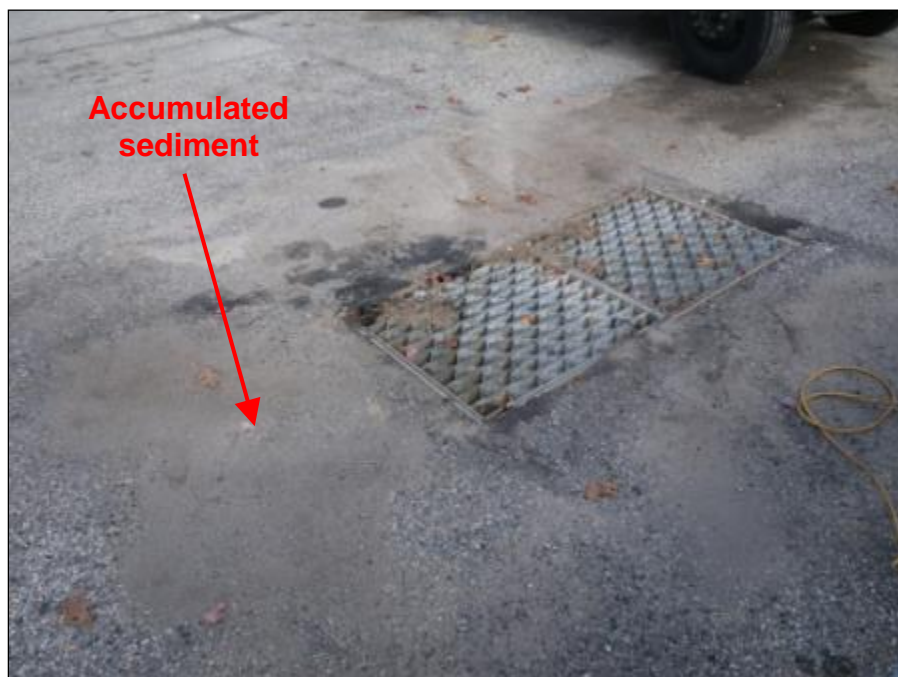
12. Accumulated sediment was present adjacent to a storm drain inlet in the vehicle storage area in the central area of the Facility (Area No. 24 on the Facility site map; refer to Photograph 20). According to the Facility site map, stormwater runoff that enters this storm drain inlet is conveyed to the permanent stormwater management basin in the southwestern corner of the Facility.

**Photograph 20.** View of accumulated sediment adjacent to a storm drain inlet in the vehicle storage area in the central area of the Facility.

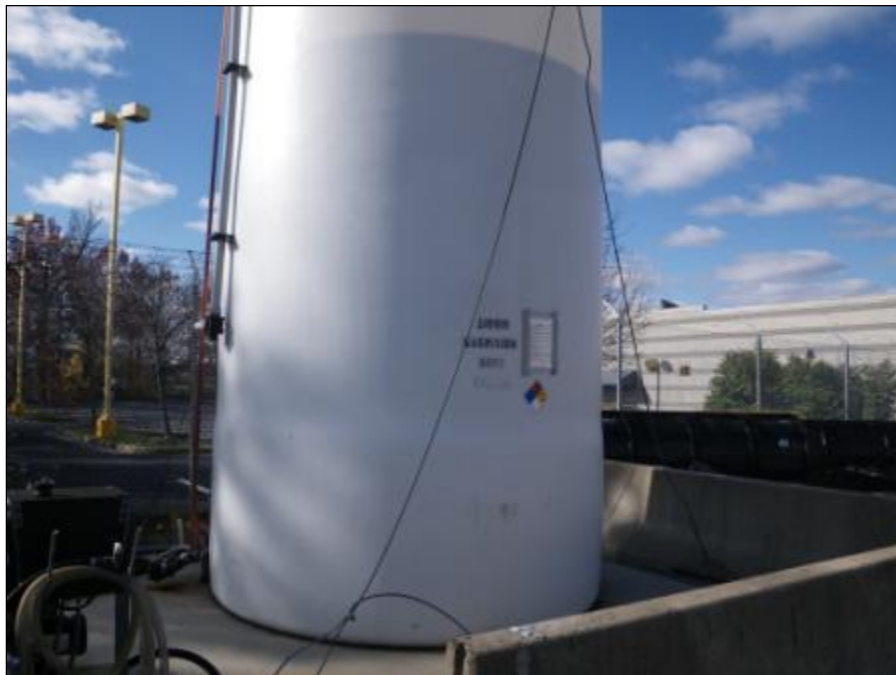
14. MDSHA staff explained that the Shop Chief conducts inspections of the Satellite Facility monthly and the DEC conducts inspections semi-annually.
15. The magnesium chloride storage tank located in the southwestern portion of the Satellite Facility was not located within secondary containment (refer to Photographs 21 and 22). The Resident Maintenance Engineer stated that MDSHA was evaluating how to achieve secondary containment for these types of tanks statewide.

**Photograph 21.** View of magnesium chloride storage tank located in the southwestern portion of the Satellite Facility. Note that the storage tank did not have secondary containment.

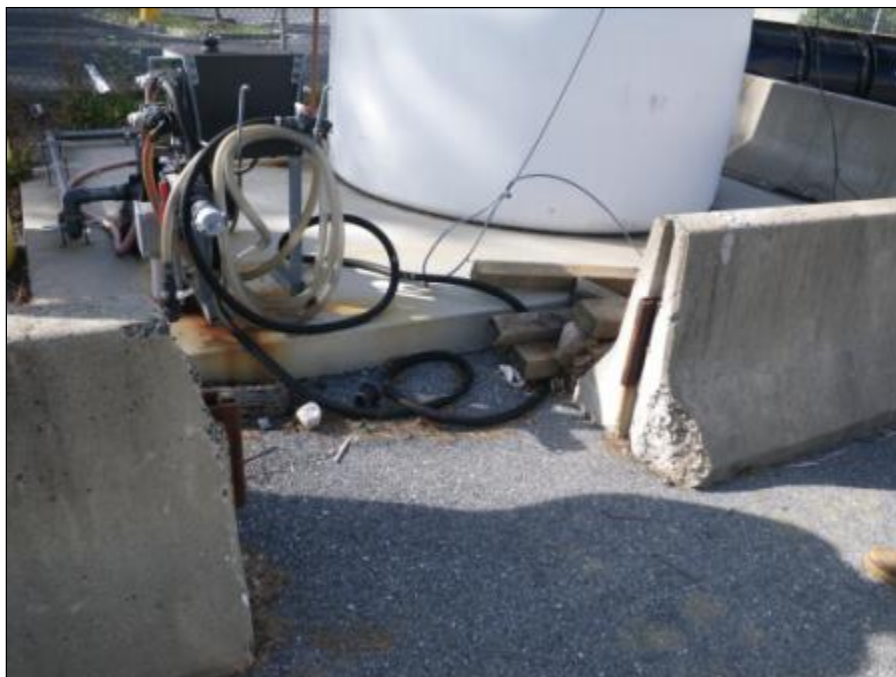
**Photograph 22.** Close-up view of the magnesium chloride storage tank area. Note lack of secondary containment.

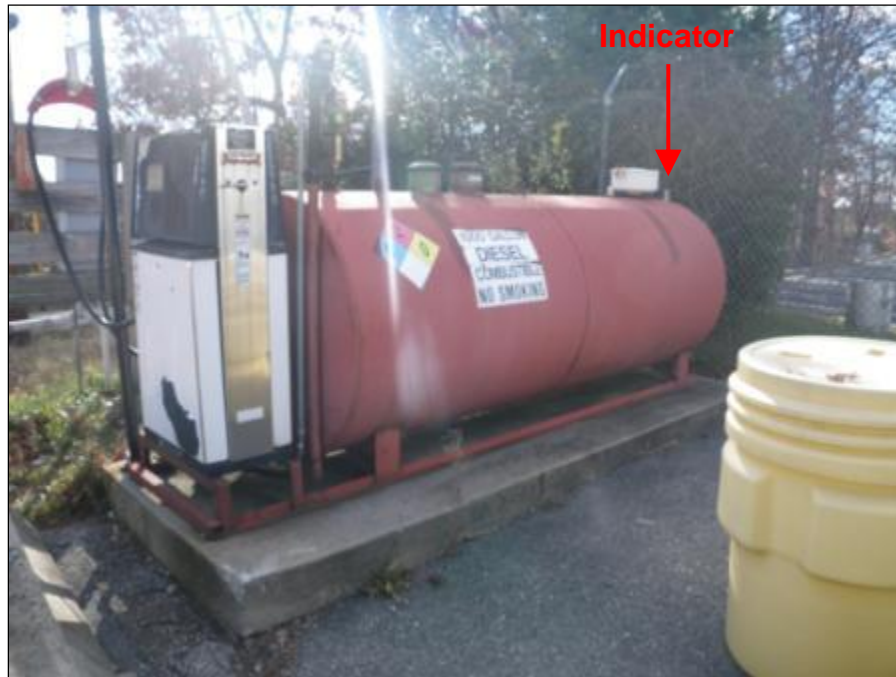
16. An indicator on the double-walled diesel fuel tank indicated fluid between the two tank walls (refer to Photographs 23 and 24). The DEC explained that this tank has had issues with condensation between the tank walls but would contact the proper contractor to pump out any accumulated fluid. He added that this tank is scheduled for an upgrade in spring 2014. A spill kit was located adjacent to the diesel fuel tank (refer to Photograph 23).

**Photograph 23.** View of the double-walled diesel fuel tank. Note that an indicator on the unit signaled that there was fluid between the two tank walls at the time of the inspection.

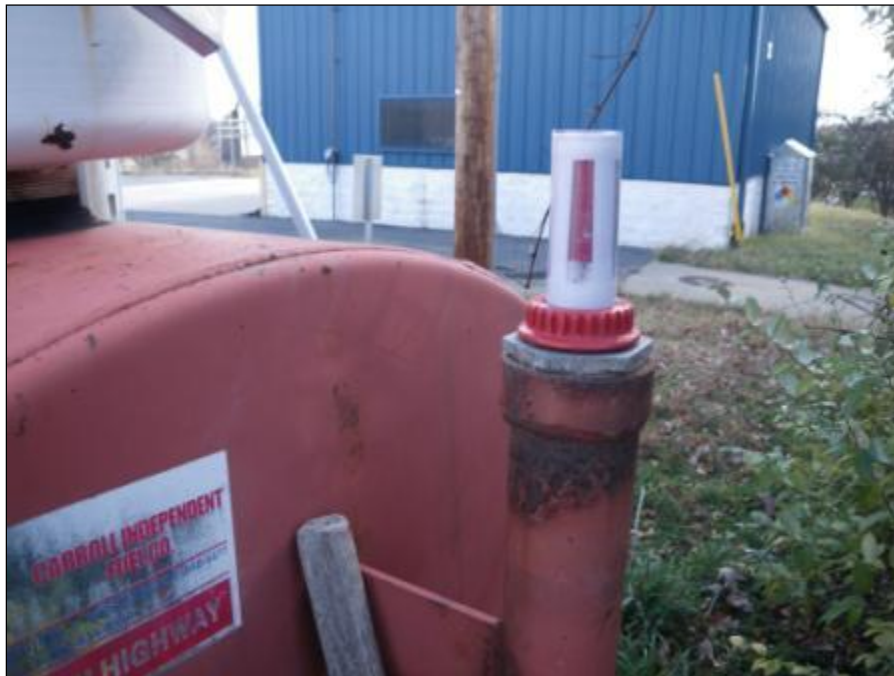
**Photograph 24.** Close-up view of the indicator on the double-walled diesel fuel tank.

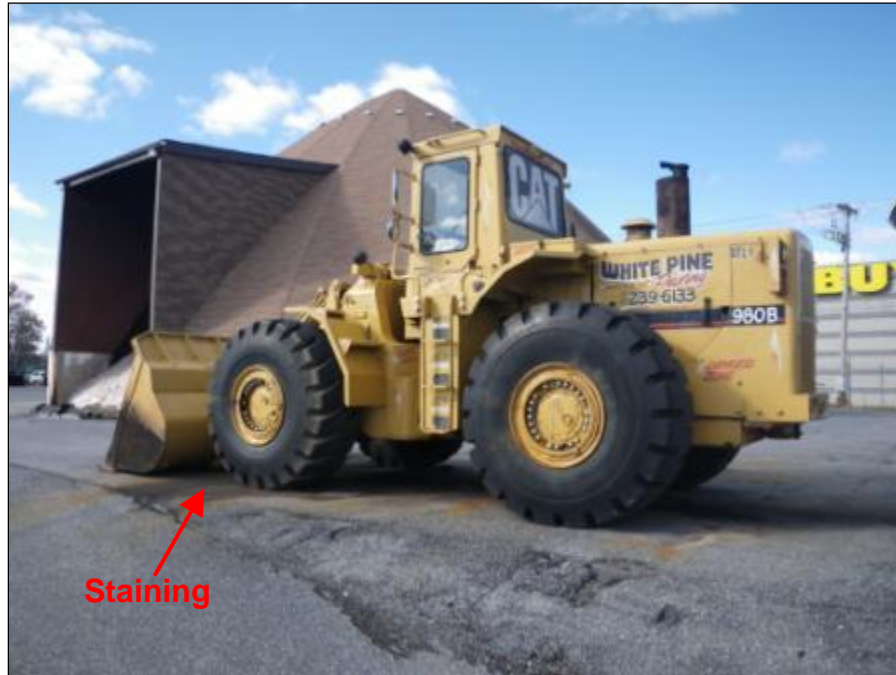
17. Staining was present underneath a front loader stored at the Satellite Facility (refer to Photographs 25 through 28). MDSHA staff explained that the equipment is the property of a private contractor, White Pine Paving, who conducts salt loading operations for MDSHA. Table 6, Summary of Oil Storage and Secondary Containment and Potential Pollutant Sources and Existing Management Practices, of the Satellite Facility SWPPP/SPCC did not indicate that drip pans should be used under heavy equipment or vehicles stored onsite.

**Photograph 25.** View of front loader stored at the Satellite Facility. Note staining underneath the front loader.

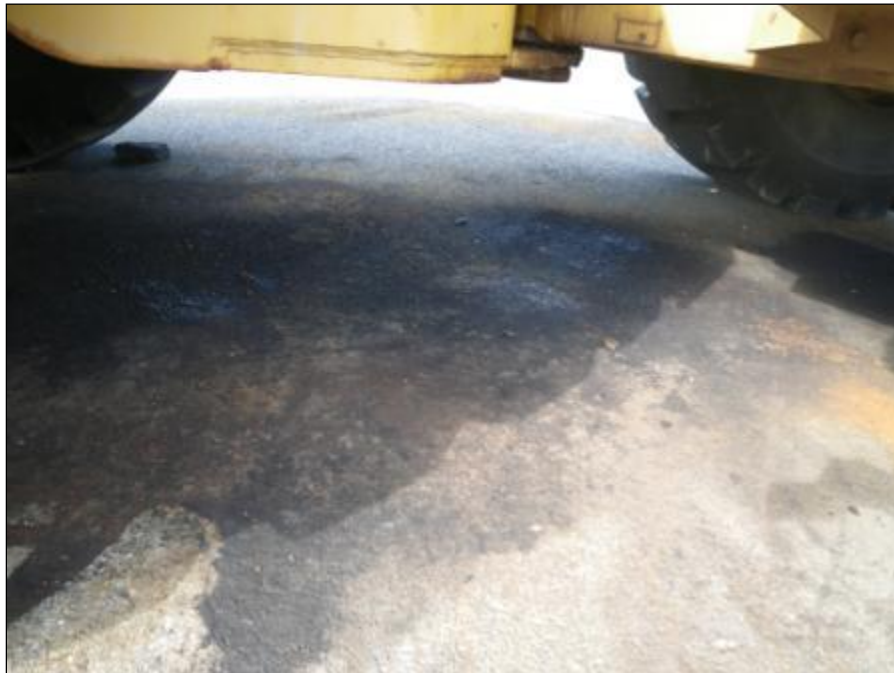
**Photograph 26.** Close-up view of staining underneath front loader stored at the Satellite Facility.

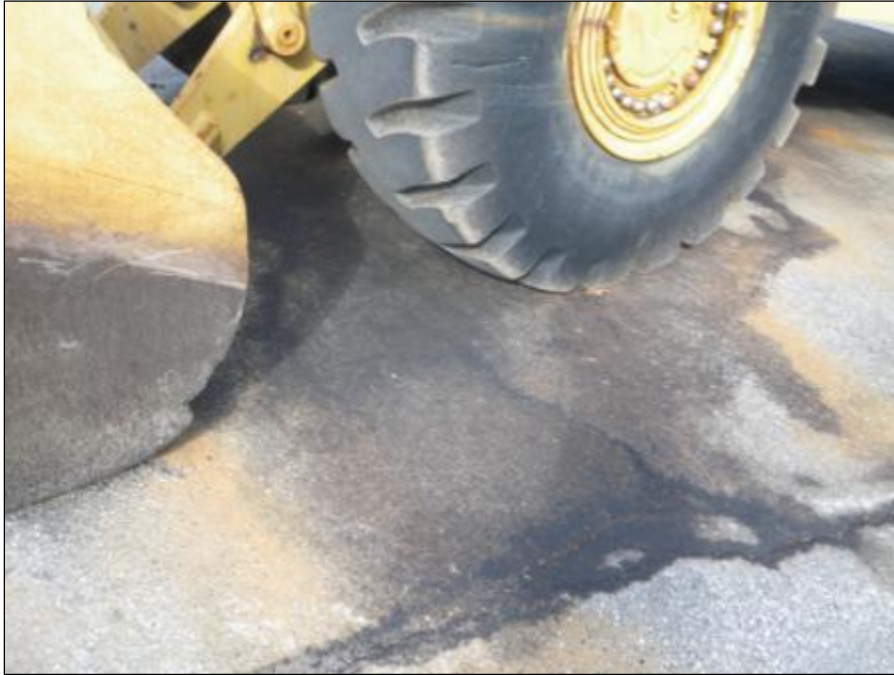
**Photograph 27.** Additional close-up view of staining under front loader stored at the Satellite Facility.

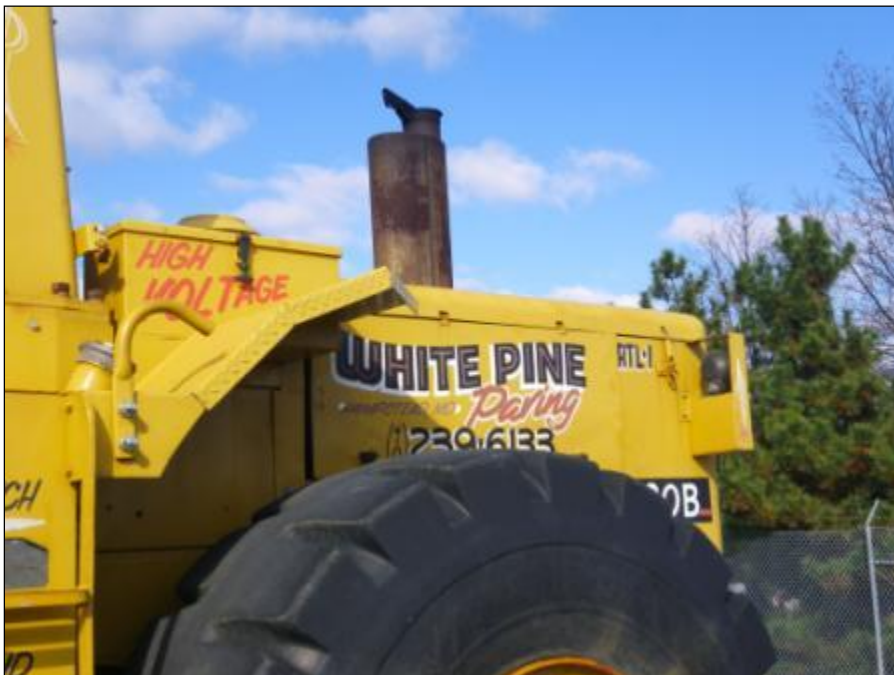
**Photograph 28.** View of the side of the front loader. Note that the equipment is the property of a private contractor, White Pine Paving.
